Transportation Safety Board
of Canada

TRANSPORTATION SAFETY

REFLEXIONS

Issue 22 – July 2005

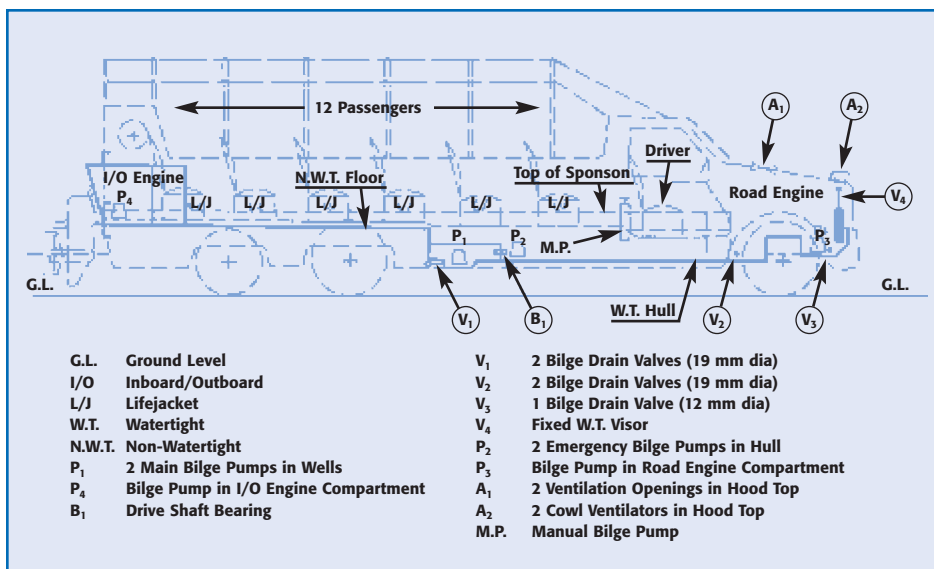
Construction profile outline

combined discharge capacity of these two pumps did not stem the increasing ingress of water overflowing the forward visor and the vehicle trimmed progressively by the bow. These pumps were the only operational pumps whose discharges could be observed from the driver's position. The two main bilge pumps were inoperable.

The bilge pumps were not installed in accordance with manufacturer instructions. Specifically, the wiring connections to the pumps were not watertight or adequately secured, and the main pumps were over-fused. Debris in the impellers stalled the pumps and, as the fuses were too large, induced the failure of the pump motors. Of the six electrically driven bilge pumps, the two that were effectively operable did not stem the ingress of water.

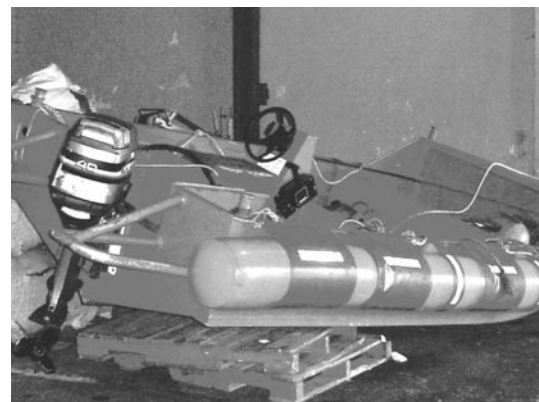
The firefighting effort, while well intentioned, was ill-advised and poorly executed. A review of the Fire Drill Muster List indicated that the crew did not proceed to the designated emergency stations. Instead, crew members reacted to the emergency situation individually and took upon themselves different roles, leading to an uncoordinated response. This culminated in

The rescue boat

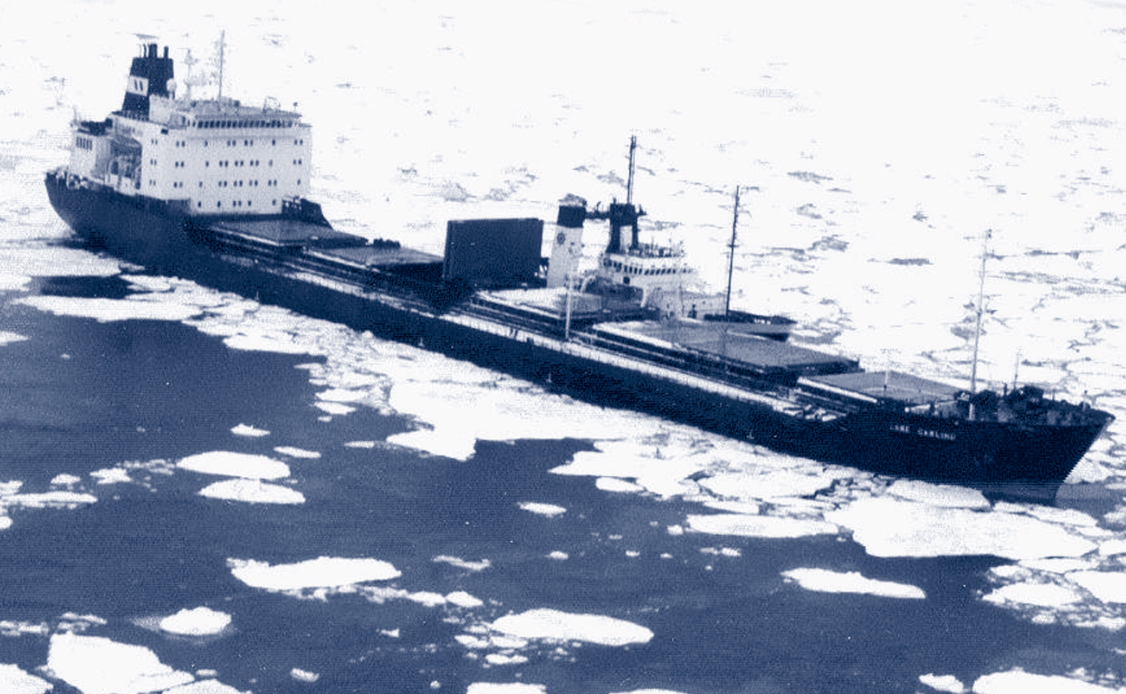
The *Lake Carling* stopped in ice, 22 March 2002 (assisting tug, the *Ryan Leet*, seen on the port side)

The principal fracture was on the port side frame at frame 91, extending upwards and forward from the toe of the weld at the base of the side shell frame. The fracture traversed frames 92 and 93 through the H and J strakes, terminating just short of frame

94 (K strake) in the No. 4 upper water ballast tank, which was empty at the time. The shell fracture divided at the juncture of the ballast tank sloping plate: one branch continuing for 45 cm on the ballast tank sloping plate at approximately 90° from the juncture point, and the other branch on the ship's side continuing up and forward for approximately 40 cm past the juncture point. Visual inspection and laboratory analysis indicates that the principal fracture originated at the base of frame 91 (at the toe of the weld). The fracture origin was located 1.3 m below the neutral axis of the vessel's midships section modulus.

The principal fracture was the forward half of a crack manifestation that presented itself on either side of the base of the frame. Five similar crack manifestations were found in the No. 4 hold: on the port side, at frames 89 and 93, and on the starboard side, at frames 85, 91 and 96. All crack manifestations appeared to originate near the base of the frame at the toe of the weld, and giving rise to two cracks, one forward and one aft of the frame, each some 75 mm in length and generally in a characteristic "V" formation. All of these cracks were rusted and appeared to have been present for some time.

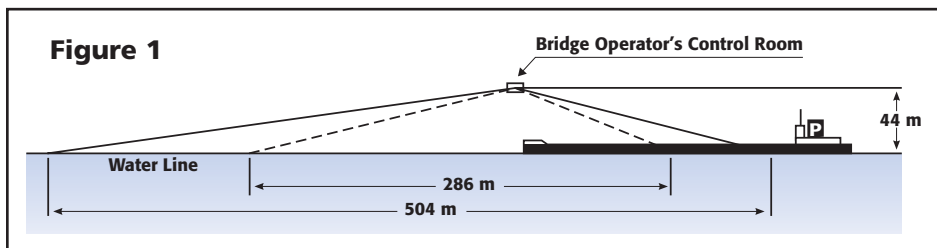
Diagram of a bridge operator's field of view when the bow of the vessel is under the operator's control room. Bridge is in the fully raised position.

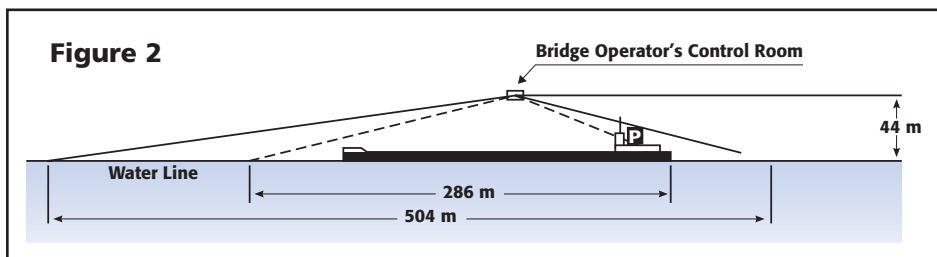
Diagram of a bridge operator's field of view when the vessel is amidships under the operator's control room. Bridge is in the fully raised position.

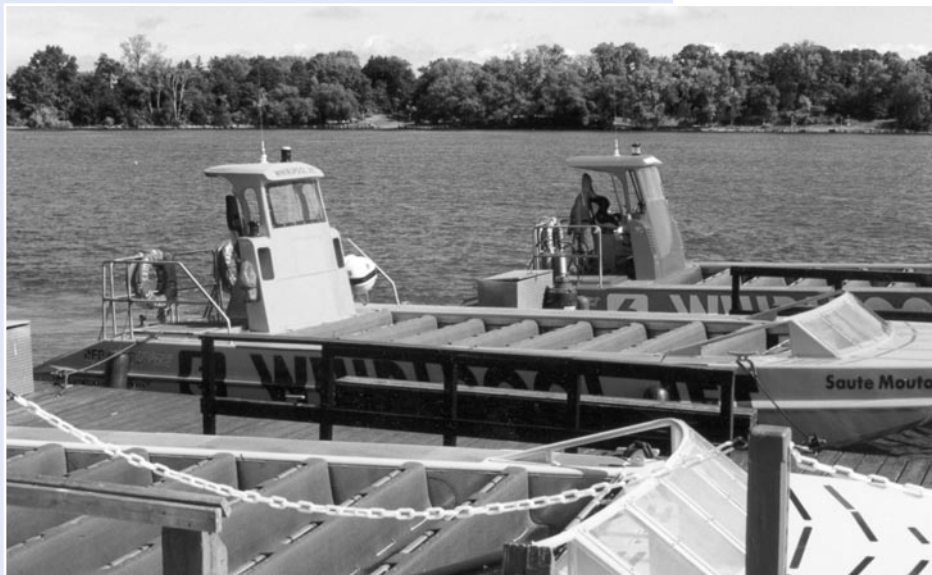
About three-quarters of the way through the rapids, the passenger area remained full with water and the vessel approached a large trough and subsequent wave in quick succession. The vessel proceeded into the trough and wave with no let-up in speed. The forward section of the windshield of the *Saute Moutons 14* and the forward half of the passenger compartment disappeared from view, after having passed through the wave. These passengers were completely submerged for approximately four to five seconds beyond the wave before the forward half of the vessel rose to the surface.

Immediately before the occurrence, the time between wave encounters did not allow the vessel to evacuate the water and re-acquire its normal operating draught. Thus, when the vessel bow dipped down into the next wave trough, it did not rise with the next approaching wave but rather ploughed into it. The availability of the high engine horsepower (1620 HP) applied to the water

Passenger water jet boats

The passengers were waist and chest deep in water.
